# Restoration progress: Northfield 1888 Milwaukee Road Depot

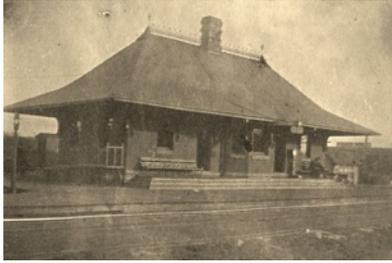
1896 (photo courtesy of Carleton College)

Three trackside steps, cottage style windows, station master bay, order board, ornate chimney and roof cresting.

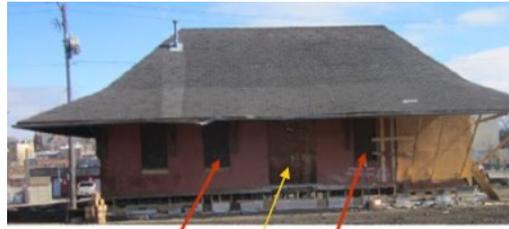
2016 after move

Red arrows = Doors converted to windows in 1944. Yellow arrow = Bay removed in 1944 and double door installed.

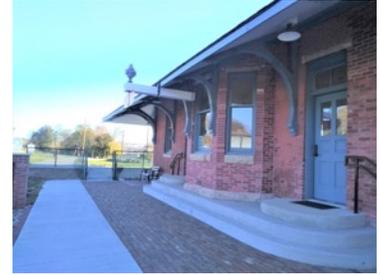
2021

Added bay, steps, paver platform, and order board; converted windows back to doors; and replaced windows.

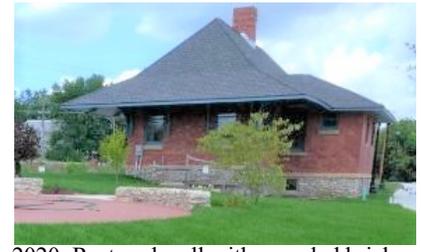
2020: Restored wall with recycled brick, two windows, original water table, and original limestone on foundation.

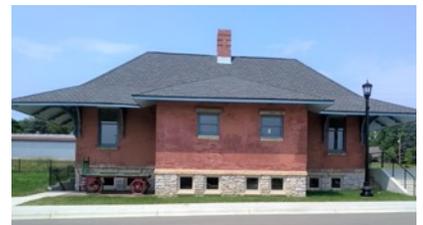
2020: Sidewalk and driveway added by City. 1920s baggage cart donated.

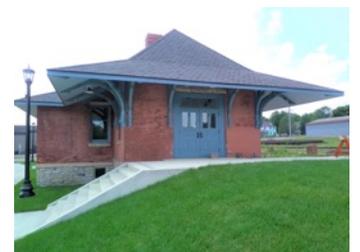
2020: North side sod, steps, light pole and platform added by City.

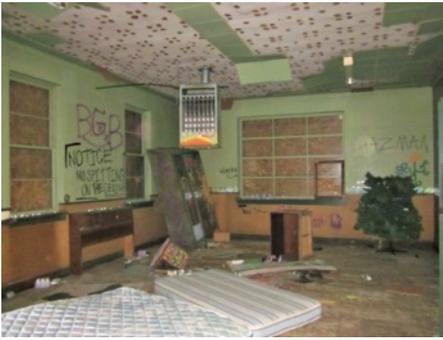
2016: Reflects 1944 changes: ceiling lowered 2 ft.; 1" of plaster added over wood walls. Left: Door converted to window. Center: Large window replaced 2 windows.

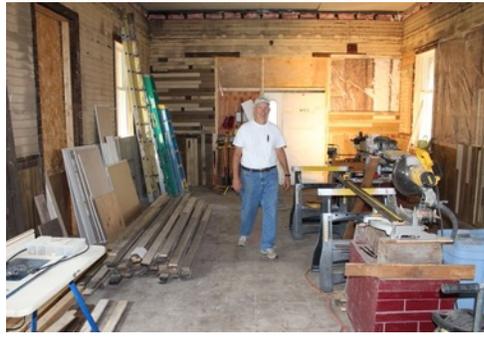
2018: Ceiling raised 2' to original position; plaster removed revealing original v-board; v-board repaired and painted; missing crown moulding replaced; original door opening on left restored; handicapped accessible double door installed; new doors custom made from 1888 blueprints; 2019: Window and door trim installed; school house lights added

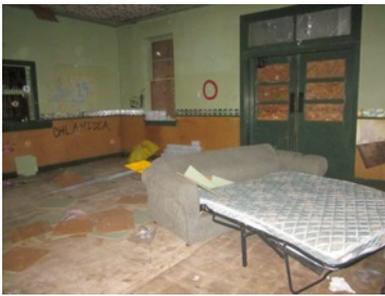
2016: Reflects 1944 changes noted above, plus, station master bay removed and replaced with double doors.

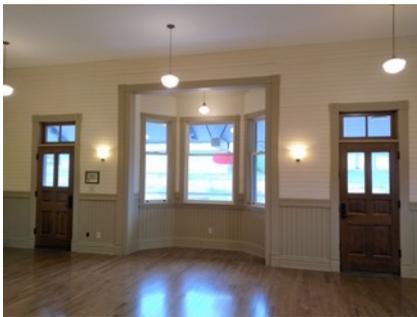
2019: 1888 blue prints used for station master bay restoration and custom-made doors & transoms. 1944 window restored to doorway on left.

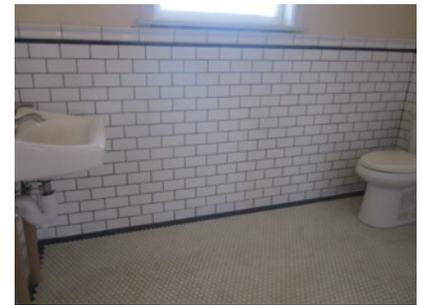
A portion of 1888 baggage room/ 1911 coal bin converted to handicapped accessible restroom.

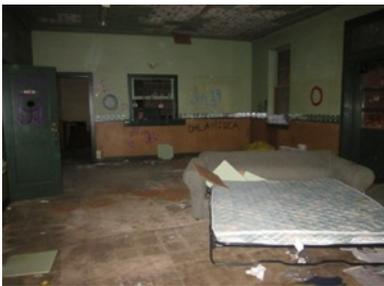
2016: Reflects 1944 changes noted above, plus, addition of a wall at end creating an office for the station master with ticket window.

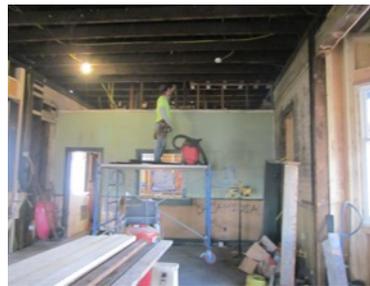
2017: Retained 1944 wall; extended wall 2 ft. to the original ceiling height.

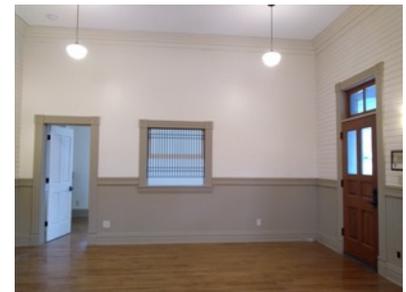
2019: Installed crown moulding at ceiling (similar to original); door and window trim; wainscoting moulding; and maple flooring throughout. Ticket window grate restored.

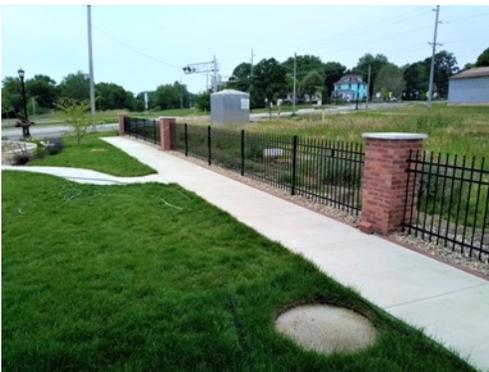
Sidewalks, safety fence with recycled brick columns and recycled brick pavers along sidewalk.

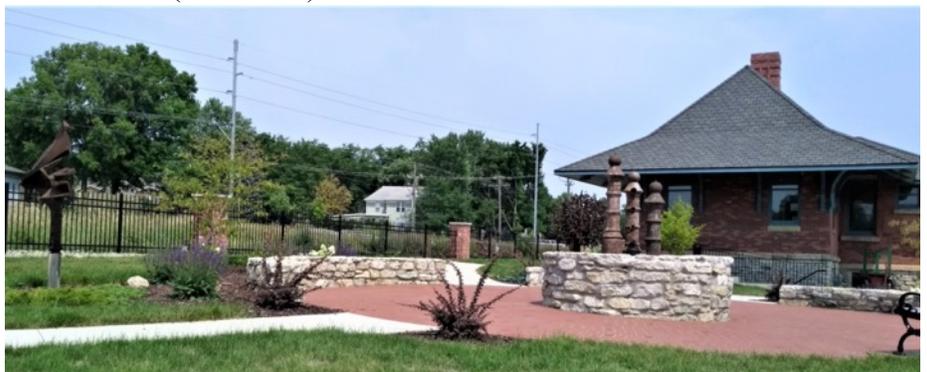
Landscaped sculpture garden: two sculptures, paver plaza, limestone seating walls, benches, and center water feature using bollards from 1886 2<sup>nd</sup> St. bridge.
